Manhole Inspection Summary

Manhole # S15Q__013MH

Location Address: **2700 wilkens av**

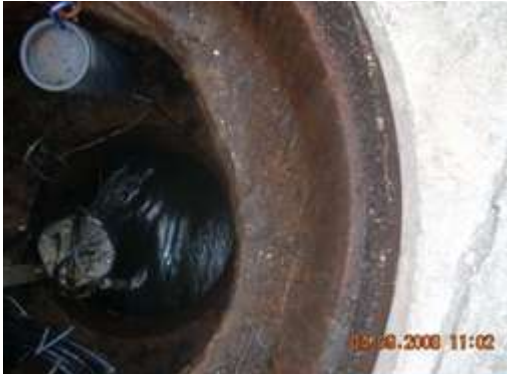
Defect 1

Frame Offset: **4** (in.) Condition: ☒ Sound ☐ Cracked ☐ Leaks

frame offset

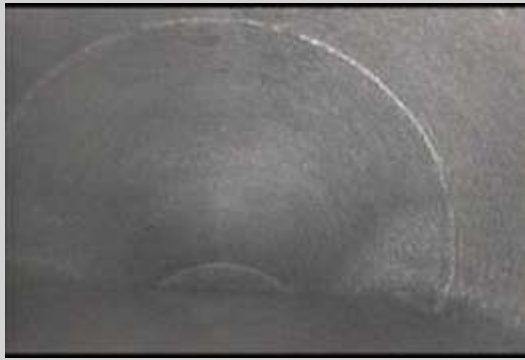
12 O'Clock Outflow

27 in. Circular Gravity Sewer
Pipe Out @ 12 O'Clock

Pipe Height: **28.8** (in.) Rod and Bar (Angled)
Pipe Material: **Concrete** ☐ Pipe Lined
Invert Depth: **8.28** (ft.) Flow Characteristics: **Turbulent**
Deposits: ☒ None ☐ Mud ☐ Sludge ☐ Debris ☐ Grease
Silt Depth: **0** (in.) Deposits Extent:
Infiltration: **None** Pipe Seal Cond: **Unknown**

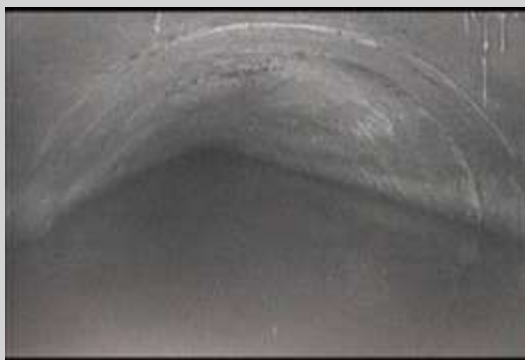
6 O'Clock Inflow

27 in. Circular Gravity Sewer
Pipe In @ 6 O'Clock

Pipe Height: **27.6** (in.) Rod and Bar (Angled)
Pipe Material: **Concrete** ☐ Pipe Lined
Invert Depth: **8.20** (ft.) Flow Characteristics: **Turbulent**
Deposits: ☒ None ☐ Mud ☐ Sludge ☐ Debris ☐ Grease
Silt Depth: **0** (in.) Deposits Extent:
Infiltration: **None** Pipe Seal Cond: **Unknown**
